## **SAFETY PERSPECTIVE FOR DAM CONSTRUCTION – CASE STUDY OF GARARDA DAM FAILURE**

## **4.0 CASE STUDY OF GARARDA EARTHEN DAM (RAJASTHAN)**

### **4.1 Examination of failure**

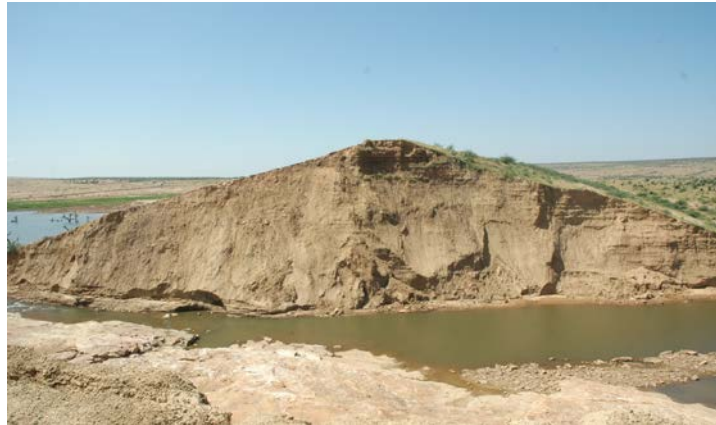
- a) A homogeneous embankment section was constructed using CL/CI clay material against the zoned dam section designed/proposed.

**Fig 1: Homogeneous embankment section**

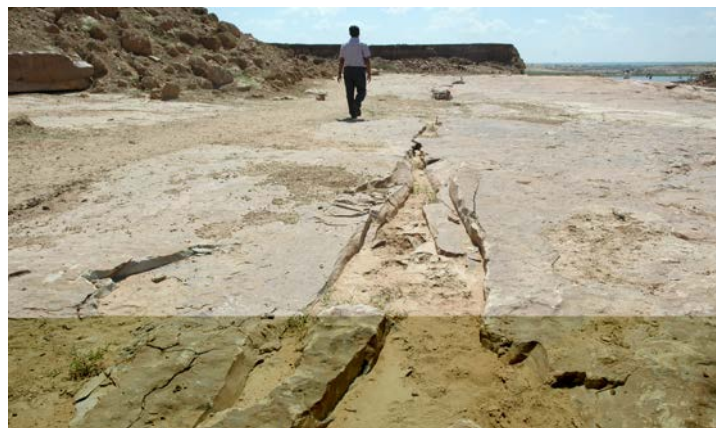
- e) The dam in the breached portion (also the deepest river bed portion) was found to have been constructed on a jointed/fractural rock mass. Many wide, deep and continuous joints were seen running from upstream to downstream both longitudinal and transverse, covering the whole area of the breached dam section. No sealing of these joints was done, and the foundation cleanup was also not done properly before taking up the earth work.

**Fig 2: Breached Section foundation area showing rock joints running continuously from upstream to downstream**

- a) The foundation of the closure section did not appear to have received the level of preparatory treatment that is typically required. No systematic consolidation/curtain grouting of the rock foundation was done. This was evident from the wide, deep and continuous joints, both with and without fill material, seen running from upstream to downstream. This could have caused washing of the fine material under increasing reservoir head, leading to differential settlements and slope instability.

- d) The dam foundation preparation and cleanup should be given due importance. Any laxity on this score can prove hazardous later on.
- e) The contact surface between the core of the closure section and the existing dam should be appropriately sealed. Also continuity of filters should be ensured.

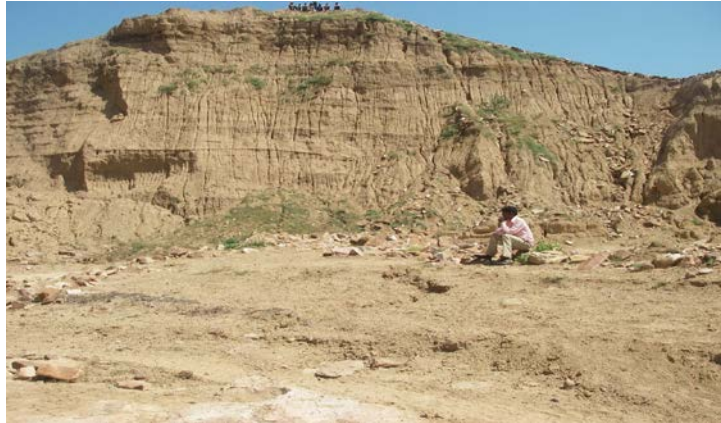
- f) Filter arrangements were not provided properly. Infact, it was difficult to confirm by visual inspection of the breached section as to whether any chimney filter (vertical/horizontal) has been provided in the dam section.

**Fig 3: Breached section showing no visible signs for confirming the presence of chimney filter**

- b) The filters (both horizontal and vertical) perform the important function of reducing the pore water pressure and blocking the migration of clay particles. The filter provided at the closure section and elsewhere did not meet the prescribed specifications as they had got mixed with shell/core material, and thus failed to perform the intended function. Laboratory tests done subsequently showed that the filter had almost become impervious and its permeability was of the order of  $1 \times 10^{-5}$  cm/s.

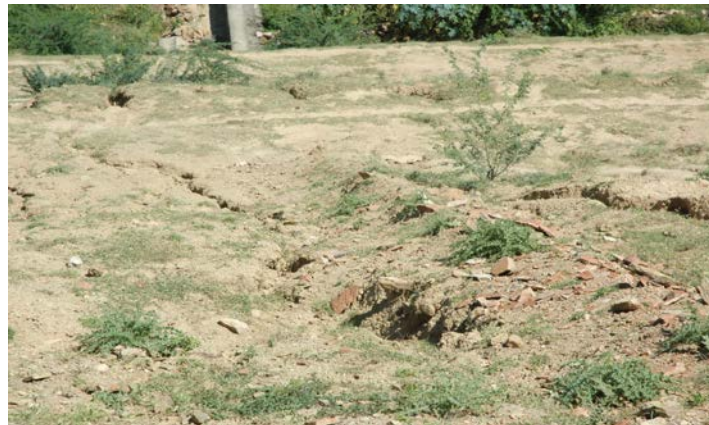
- g) Deep rain cuts were observed on the downstream side pointing towards improper compaction of the soil used as dam material along the slope.

**Fig 4: Downstream slope showing deep rain cuts and excessive weed growth**
