## **CANAL LINING THROUGH GEOMEMBRANES : A CASE STUDY OF SARDAR SAROVAR PROJECT**

*Comparative field trials of IITD geomembrane and 0.3 mm HDPE sheets having similar weight per unit area are reported in this paper. The selected canal was a part of Sardar Sarovar Narmada Nigam canal system - "Tanchha Distributary", near the village Anor of Amod Taluka, Bharuch District of Gujarat. The canal section of ~3.2 km length was found to have been suffering very high seepage loss and surrounding farms were waterlogged. This water loss was associated with and ascribed to the expansive soil types (CH), referred to as black cotton soil. To compare the working with and effectiveness of different geomembranes, three materials - 0.3 mm HDPE, 0.3 mm LDPE and IITD geomembrane were chosen. Observations during execution and during post implementation period of six months are that there are installation limitations of 0.3 mm HDPE while the*

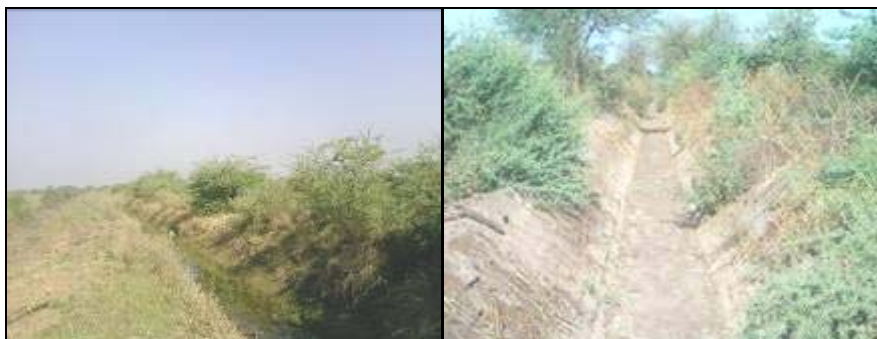
The deteriorated condition of the canal can be viewed in Photos-1 and 2. The bed of the canal was also unusually swollen. There were several other issues. The banks were disbursed and scattered. The canal section at one location was found to be much wider in comparison to what it was originally. The embankments had also been dislocated. At several locations, cracks and breaches were patched up by cement mortar or through plastering to restrict water seepage. The local farmers were forced to construct bunds on either sides of the canal to patch up the failure of the embankment. However, this solution was not satisfactory because of the propensity of the canal embankment to break repeatedly and suddenly.

**Photos - 1 and 2 Bad Condition of Tanchha Distributary**

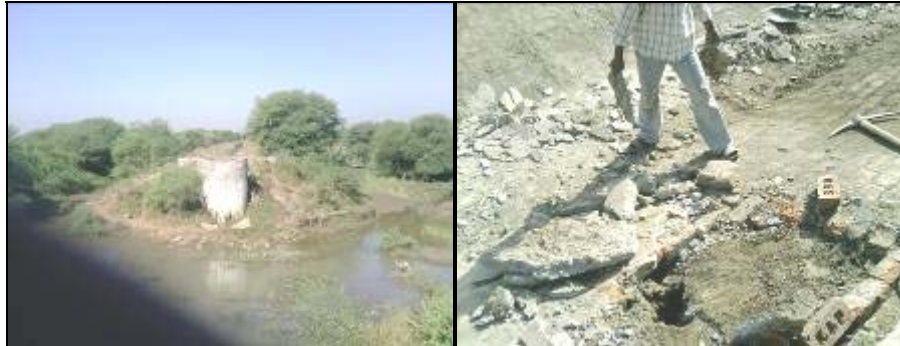
Piping from canal banks and leakage from canal siphons both contributed to the seepage. Photos-3 and 4 show the seepage from the canal siphon and a through hole in the embankment. These occurrences used to result in water inundation of the surrounding areas.

**Photos – 3 and 4 Leakage and Identification of Piping through Banks**

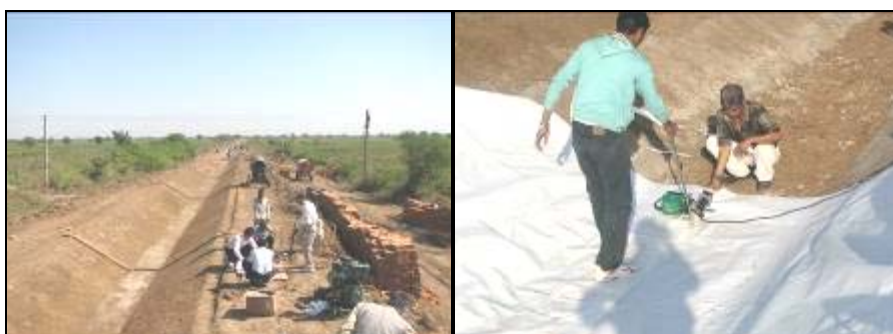
Rolls of 80 to 85 meter length were available for all three materials. Heat sealing was required to be carried out on site. Machine parameters were optimized for this process. For all three materials, heat sealing on site was a rather simple and straightforward process.

**Photos – 5 and 6 Preparation of Canal Section and Heat Sealing of Geomembrane**

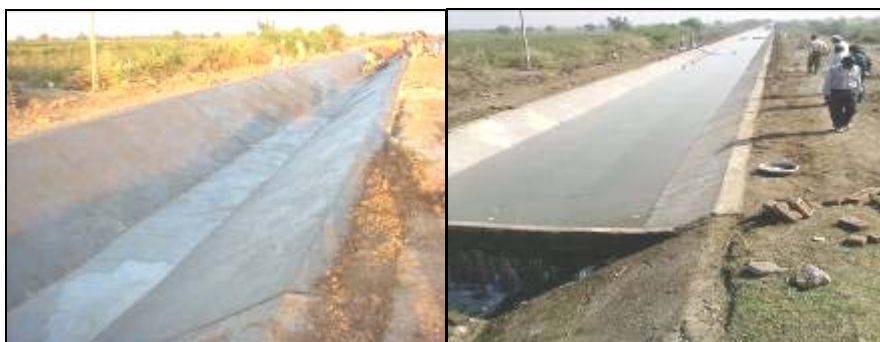
After completion of each of the three sections with the respective geomembrane materials, testing was carried out. This testing was carried out by filling water within the upstream and downstream bunds and was done for a period of over 60 days. In the forthcoming irrigation season i.e. beginning from 1-10-2011, water flow through the canal was initiated as is normally done through the canal. No seepage or leakage was observed for over a month on either side of the canal. Since the embankment section was not too wide, a comparative measurement of hydrostatic pressure in the pre-application and post-application scenario was not felt useful; only visual observation was resorted to in order to make assessment of the effectiveness of the solutions implemented.

**Photos – 7 and 8 Completed Canal Section**
