## **RCC PORCUPINES AN EFFECTIVE RIVER BANK PROTECTION MEASURE – A CASE STUDY OF PROTECTION OF MAJULI ISLAND**

### **Synopsis**

The paper gives an overview of the Permeable structures in the form of RCC porcupines for bank protection measures and their successful application at Majuli Island.

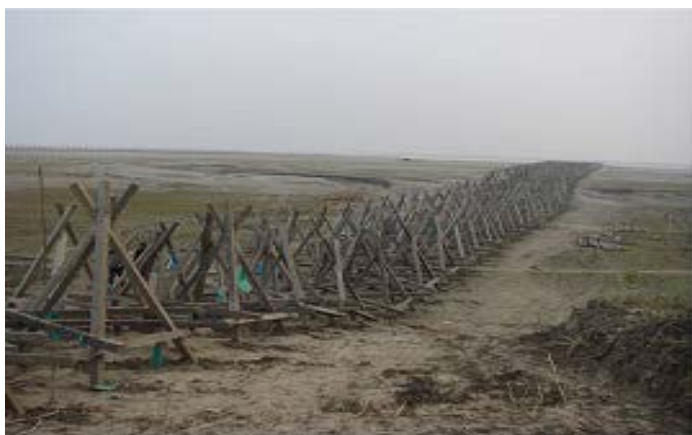
**Fig.-3: Reclamation of land due to porcupine screens**

A panel of Experts visited the island in Nov. 2010 and noticed significant improvement in the situation of Majuli area due to various measures taken up for protection of flood protection as well as erosion control. It was observed that since 2004-05, no embankment breached in south bank of Majuli island. It was also noticed that after a long gap of 20 years, harvesting of Sali paddy in Lower Majuli area has started and at several places large tracts of land have been reclaimed by inducing siltation near the bank as shown in Fig.-3.

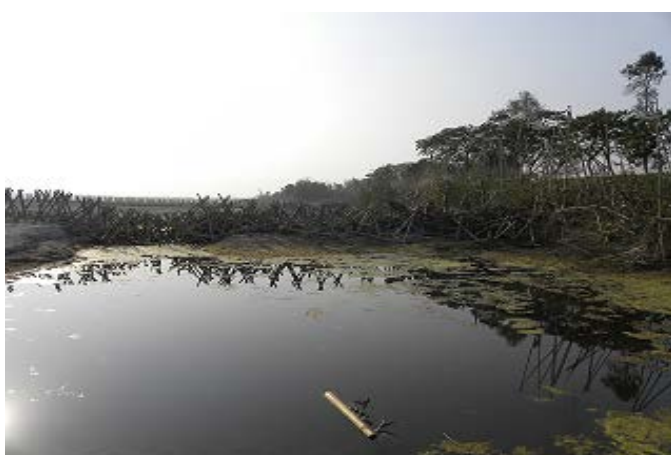
**Fig.-4: Siltation induced due to RCC porcupines**

Fig.-4 shows the signs of siltation at various locations due to RCC porcupines as noticed by the panel of experts.
