# Depletion of water resources and degradation of water quality in Alleppey district, Kerala, India

Sarath Syamaprasad, Sushmit Das, Deewakar Golyan  
*Undergraduate Student, Amity School of Engineering & Technology, Amity University*

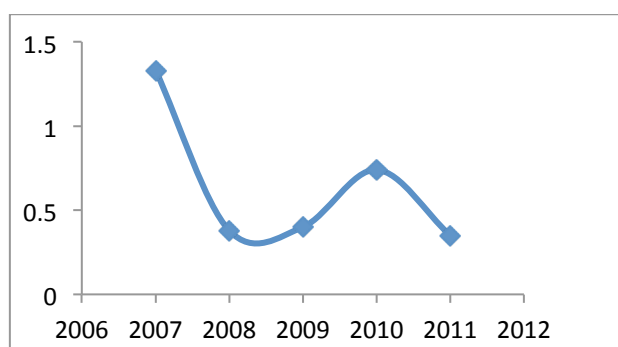
**Figure 6.** Trend of water level in Nedumudi

The Places selected for the study of water level is a part of the study area in focus. The groundwater level has shown an all-time low value of 0.35 in Nedumudi. Ramankary had its ground water level depleted to 0.29m in the year 2010, however it has improved to 0.68 in 2011. The depletion of water table is illustrated in the graphs below and from the declining trend we must conclude that the potable water resources are getting depleted in the study region.
