| <p style="text-align: center;"><b>Improving Irrigation Efficiency: Lining of Canals</b></p> <p style="text-align: center;"><b>A Case Study of Rajasthan Feeder and Sirhind Feeder Canal</b></p> | |
| <p style="text-align: center;"><b>SHIV KUMAR SHARMA</b><br/> <i>Director, Barrage and Canal Design (N &amp; W) Directorate, Central Water Commission, New Delhi</i><br/> sksharma_engg@yahoo.co.in</p> | |

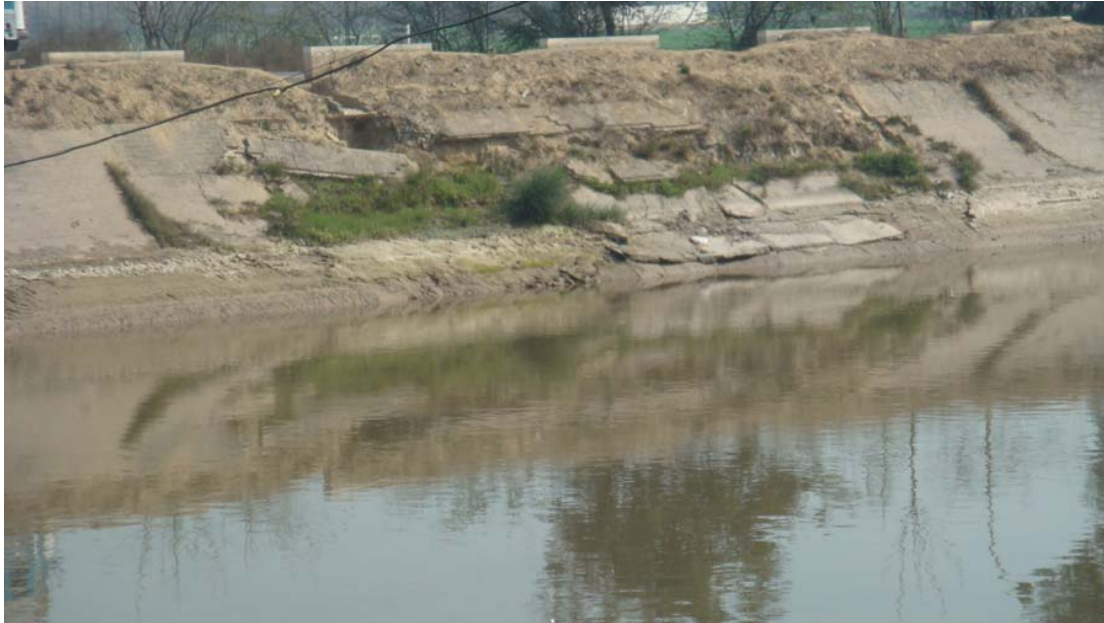
These two canals were taken up for construction in 50's and were completed in 60's. Both the feeders were constructed as lined channels with single brick lining on bed and double brick lining on side slopes. These canals have been running continuously for past 50 years (app.) Only minor maintenance of these canals has been carried out with the result that these canals has deteriorated over the year causing seepage to the extent of about  $3.81 \text{ m}^3/\text{s}/10^6 \text{ m}^2$  which is much more than normally expected from lined canals.

**Photograph 1.** Damaged lining of Rajasthan Feeder

Proposals for relining of Rajasthan Feeder (RD 179000 to 496000 i.e. appox. 97 km) at an estimated cost of 952.10 crore and relining of Sirhind Feeder (RD 119700 to RD 447927 i.e. appox. 100 km) at an estimated cost of 489.165 crore were accepted by Technical Advisory Committee of Ministry of Water Resources in its 98<sup>th</sup> meeting held on 9.7.2009.

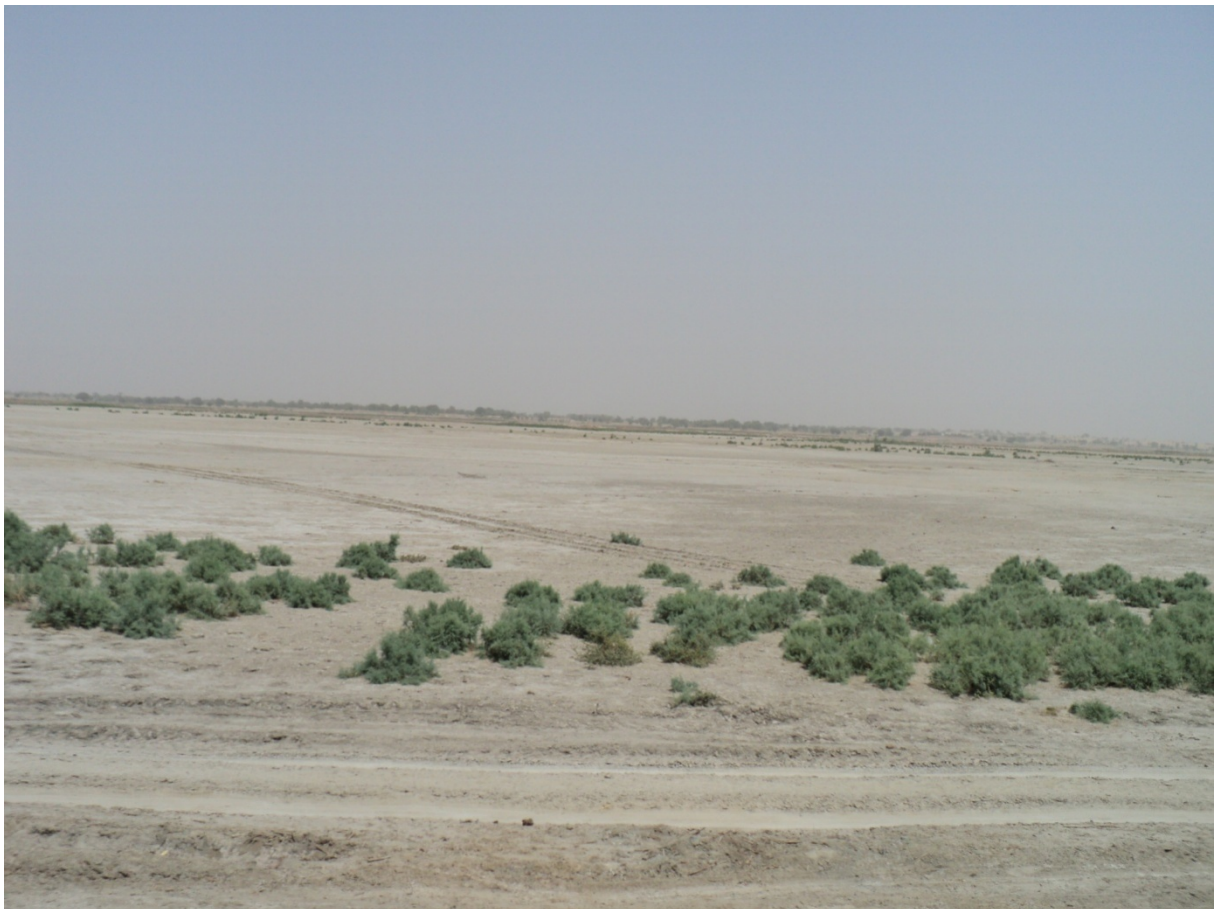
It is reported that when these canals were constructed, the ground water table was at a considerable depth from surface. Over the years this water table has risen and in some areas it has reached almost surface level. Central Ground Water Board in its report on Water logging in Mukatsar Areas has observed that seepage from canals is one of the factors causing water logging in this area. Further Ground water is saline and is unfit for irrigation. Therefore, conjunctive use of Ground Water for Irrigation is not feasible.

**Photograph 2.** Water Logged area of Rajasthan Feeder

One of main problem in relining was high ground water table of the area. Since these two canals are running parallel with a common bank, seepage was also a major concern. As the relining operation requires dry base and seepage may endanger the slope stability of side slopes, it was imperative to lower the ground water table. This problem was pointed out to Project authorities at the DPR scrutiny stage. It was suggested to Project Authorities that three rows of bore holes may be provided in DPR. It was further suggested that at the time of construction stage planning, monitoring of ground water table may be done in the vicinity of work area and suitable measures of bank stabilization, if required, may be taken.
